City of San Diego
FY15 Facility Condition Assessment Report for:
Facility # 000008 Office. City Operations Building. COB. Downtown

FACILITY EXECUTIVE SUMMARY

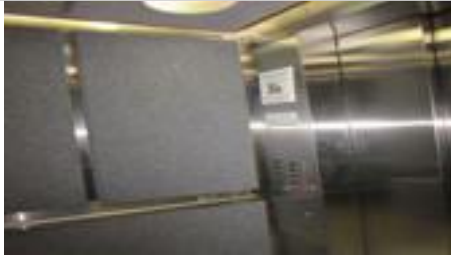
| DEFICIENCY REPORT – Building Only | | | | | | | |
|---|---|---|---|--|---|---|---|
| 2015 | Necessary | Elevators and Lifts | Replace | | 1970 System | Capital | \$21,440,921 |

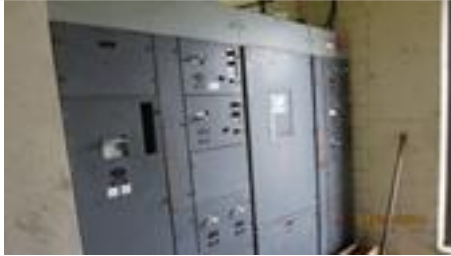
| DEFICIENCY REPORT – Building Only | | | | | | | |
|---|---|---|---|---|--|---|---|
| 2015 | Potentially Critical | Electrical Service Distribution | Replace | | Floor: Roof 1 Room: Penthouse ID: Type: Motor Control Centers | Capital | \$147,693 |

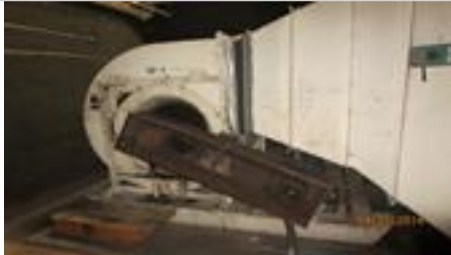
| DEFICIENCY REPORT – Building Only | | | | | | | |
|---|---|---|---|---|--|---|---|
| 2015 | Necessary | Distribution Systems | Replace | | Floor: Roof 1 Room: Penthouse ID: U-696253 Type: Exhaust Fans | Capital | \$143,900 |

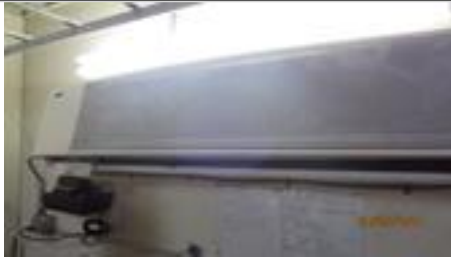
| DEFICIENCY REPORT – Building Only | | | | | | | |
|---|---|---|---|---|---|---|---|
| 2017 | Necessary | Distribution Systems | Replace | | Floor: 5 Room: Phone Room ID: Type: Fan Coil Units | Capital | \$5,350 |

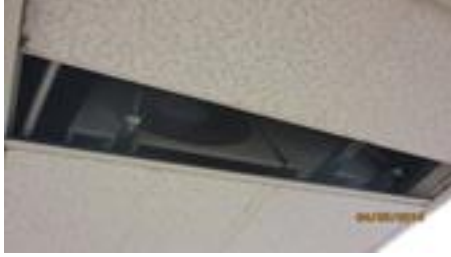
| DEFICIENCY REPORT – Building Only | | | | | | | |
|---|---|---|---|---|---|---|---|
| 2019 | Potentially Critical | Terminal and Package Units | Replace | | Floor: 5 Room: Elevator Lobby ID: Type: Air Cooled Condensing Units | Capital | \$5,006 |

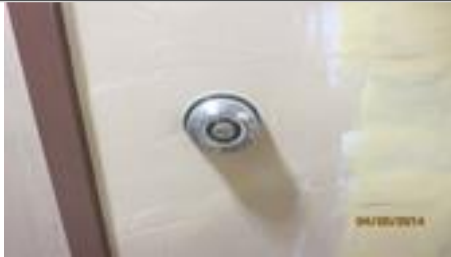
| DEFICIENCY REPORT – Building Only | | | | | | | |
|---|---|---|---|---|---|---|---|
| 2020 | Necessary | Controls and Instrumentation | Replace | | 1970 System | Capital | \$2,188,072 |

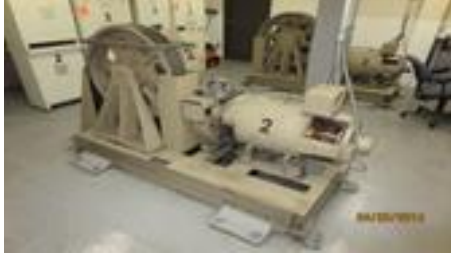
| DEFICIENCY REPORT – Building Only | | | | | | | |
|---|---|---|---|---|---|---|---|
| 2020 | Necessary | Elevators and Lifts | Replace | | Floor: Roof 1 Room: Elevator Machine Room ID: 2-40152-57 Type: Elevators | Capital | \$422,921 |

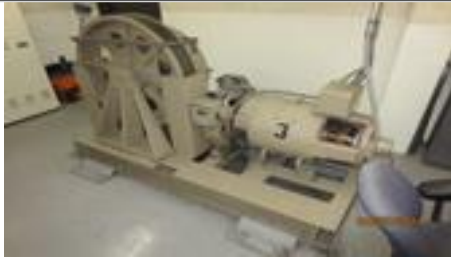
| DEFICIENCY REPORT – Building Only | | | | | | | |
|---|---|---|---|---|---|---|---|
| 2020 | Necessary | Elevators and Lifts | Replace | | Floor: Roof 1 Room: Elevator Machine Room ID: 2-4052-17 Type: Elevators | Capital | \$421,156 |

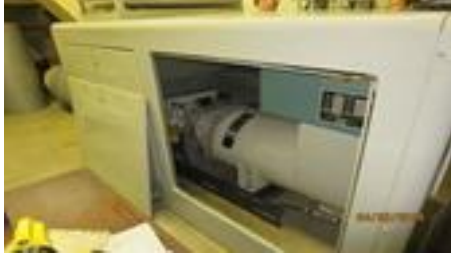
| DEFICIENCY REPORT – Building Only | | | | | | | |
|---|---|---|---|---|---|---|---|
| 2020 | Critical | Other Electrical or Generator | Replace | | 1970 System | Capital | \$395,241 |

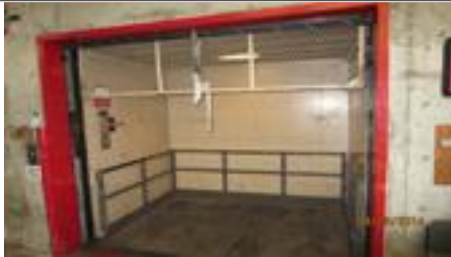
| DEFICIENCY REPORT – Building Only | | | | | | | |
|---|---|---|---|---|---|---|---|
| 2020 | Necessary | Elevators and Lifts | Replace | | Floor: B1 Room: Basement ID: Type: Elevators | Capital | \$320,644 |

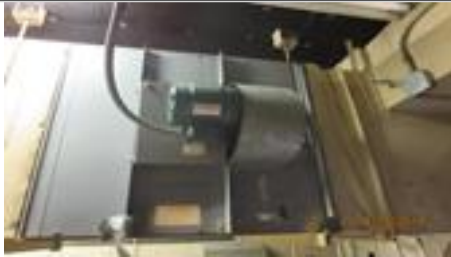
| DEFICIENCY REPORT – Building Only | | | | | | | |
|---|---|---|---|---|---|---|---|
| 2020 | Necessary | Distribution Systems | Replace | | Floor: B1 Room: Generator Room ID: 152855 Type: Exhaust Fans | Capital | \$11,050 |

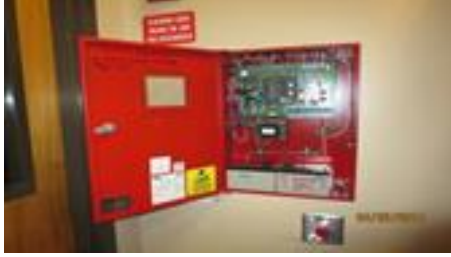
| DEFICIENCY REPORT – Building Only | | | | | | | |
|---|---|---|---|---|---|---|---|
| 2023 | Critical | Communications and Security | Replace | | Floor: B1 Room: Basement ID: 5831283014 Type: Fire Alarm System | Capital | \$23,876 |

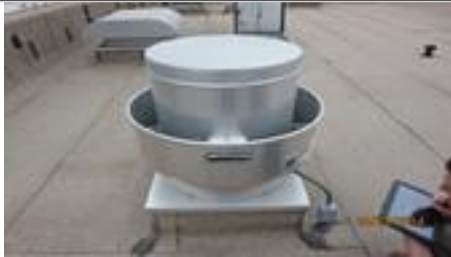
| DEFICIENCY REPORT – Building Only | | | | | | | |
|---|---|---|---|---|--|---|---|
| 2023 | Necessary | Distribution Systems | Replace | | Floor: Roof 2 Room: Roof ID: 11697785 0903 Type: Exhaust Fans | Capital | \$9,974 |

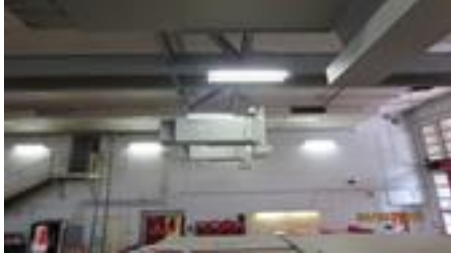
| DEFICIENCY REPORT – Building Only | | | | | | | |
|---|---|---|---|---|--|---|---|
| 2026 | Necessary | Distribution Systems | Replace | | Floor: 1 Room: Fire Station Bay ID: Type: Vehicle Exhaust System | Capital | \$48,682 |

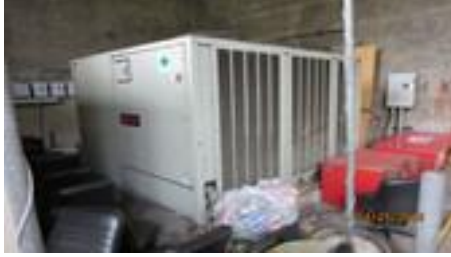
| DEFICIENCY REPORT – Building Only | | | | | | | |
|---|---|---|---|---|--|---|---|
| 2029 | Potentially Critical | Cooling Generating Systems | Replace | | Floor: 1 Room: Fire Station Bay ID: C99G14091M Type: Chillers | Capital | \$244,224 |

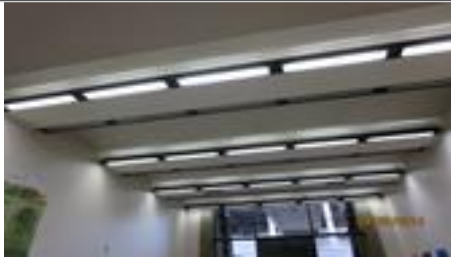
| DEFICIENCY REPORT – Building Only | | | | | | | |
|---|---|---|---|---|---|---|---|
| 2030 | Necessary | Lighting and Branch Wiring | Replace | | 1970 System | Capital | \$44,030,045 |

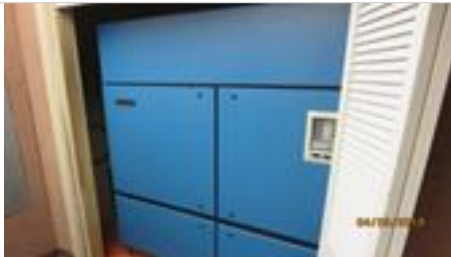
| DEFICIENCY REPORT – Building Only | | | | | | | |
|---|---|---|---|---|---|---|---|
| 2033 | Necessary | Distribution Systems | Replace | | Floor: B1 Room: Data Room ID: Type: Air Handling Units | Capital | \$83,083 |

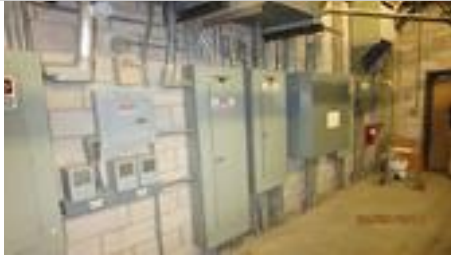
| DEFICIENCY REPORT – Site Only | | | | | | | |
|---|---|---|---|--|---|---|---|
| 2015 | Recommended | Electrical Distribution | Replace | | 1970 System | Capital | \$1,376,103 |

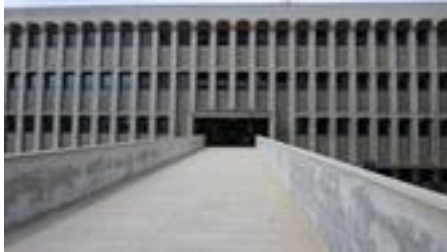
| DEFICIENCY REPORT – Site Only | | | | | | | |
|---|---|---|---|---|---|---|---|
| 2015 | Recommended | Site Development | Replace | | 1970 System | Capital | \$763,801 |

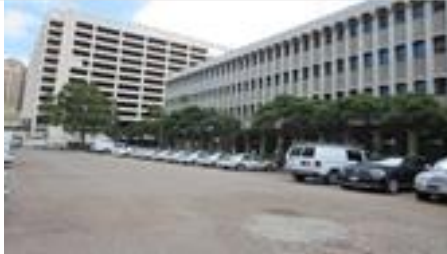
| DEFICIENCY REPORT – Site Only | | | | | | | |
|---|---|---|---|---|---|---|---|
| 2015 | Recommended | Parking Lots | Replace | | 1970 System | Capital | \$742,251 |

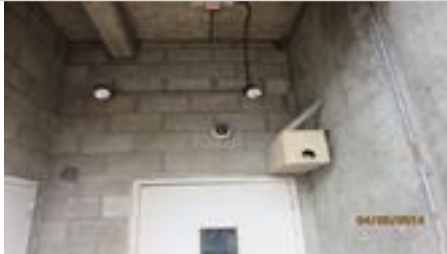
| DEFICIENCY REPORT – Site Only | | | | | | | |
|---|---|---|---|---|---|---|---|
| 2015 | Recommended | Site Communications and Security | Replace | | 1970 System | Capital | \$416,618 |

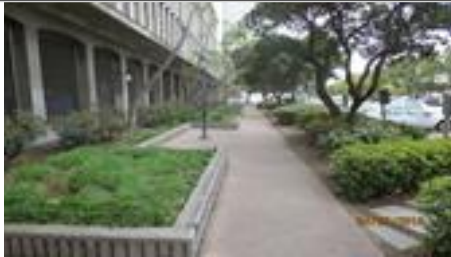
| DEFICIENCY REPORT – Site Only | | | | | | | |
|---|---|---|---|---|---|---|---|
| 2015 | Recommended | Site Lighting | Replace | | 1970 System | Capital | \$290,370 |

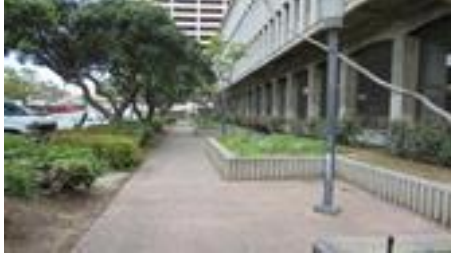
| DEFICIENCY REPORT – Site Only | | | | | | | |
|---|---|---|---|---|---|---|---|
| 2020 | Recommended | Pedestrian Paving | Replace | | 1970 System | Capital | \$524,118 |

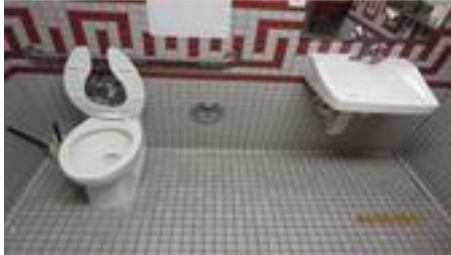
| DEFICIENCY REPORT – Site Only | | | | | | | |
|---|---|---|---|--|---|---|---|
| 2020 | Recommended | Sanitary Sewer | Replace | | 1970 System | Capital | \$384,193 |

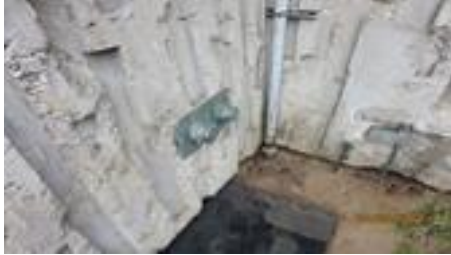
| DEFICIENCY REPORT – Site Only | | | | | | | |
|---|---|---|---|--|---|---|---|
| 2020 | Recommended | Water Supply | Replace | | 1970 System | Capital | \$164,654 |
